FAILURES OF SUSPENDED CEILINGS AND EXECUTION ERRORS

When observing the stability of suspended ceilings during operation, sometimes smaller failures are observed, up to disasters, even a few of considerable sizes and serious consequences. The aim of the article is to analyse the causes of damage to a suspended ceiling, with an area of approximately 500 m², as well as testing and checking the applied construction elements. In situ destructive tests as well as tests at the AGH laboratory were carried out. The analyses were carried out in accordance with PN/EN 13964: 2014 (E). It was found that the designed ceiling system solution was correct. Whereas in the performance, an improper spacing of hangers, even by more than 70% of the permissible spacing, and forbidden lengths of brackets from C60 profiles, were applied. Also, about 55% of the connectors had too small diameters of the ends of the mandrels, which allowed for the sliding of broken head and a sudden loss of carrying capacity of the hanger.

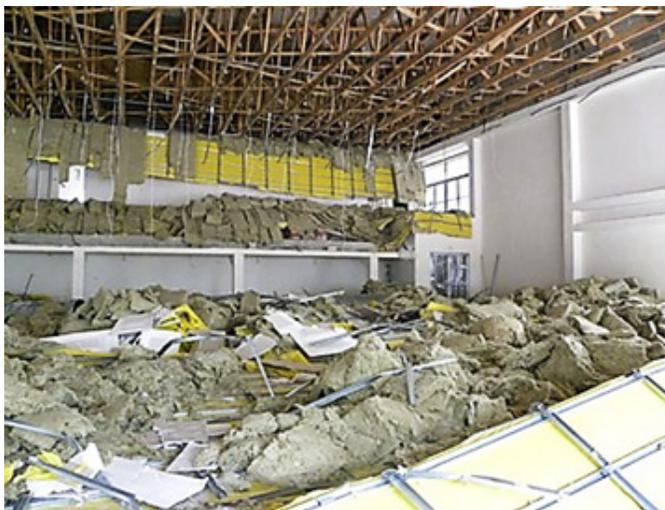
In 2010, during the construction of a sports hall in the Public School Complex No. 3 in Wadowice, the suspended ceiling over the entire area of the hall collapsed (approx. 1,000 m²). The progressive nature of this collapse led to the destruction, in a short period of time, of the entire erected structure – Figure 1. Several people sustained injuries.

Fig. 1. The collapse of the suspended ceiling in the sports hall in Wadowice, 2010

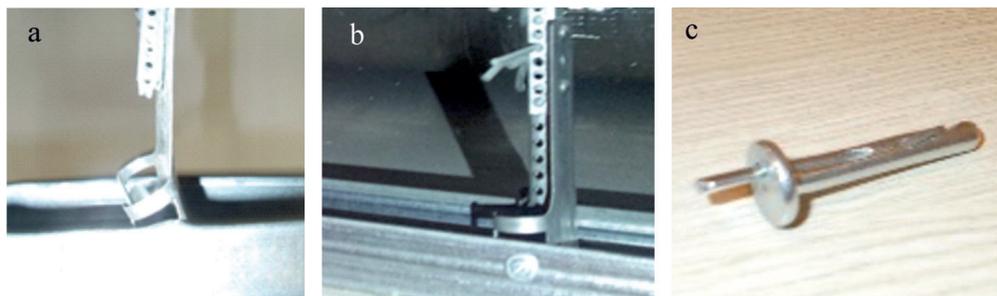
The installed hangers, each on two anchors, Figure 4a, were characterised by an average breaking load of 2.34 kN, which was by 19% and 14% smaller than the breaking loads for single anchors in the case of their extraction with heads, fixed by Company 1 and Company 2, respectively. Therefore, the application of two anchors instead of one correctly installed anchor, does not result in an increase in the average breaking load (at the same time, in accordance with Technical Approval ITB AT-15-7305/2014 Metal expansion anchors, [2], the application of anchors with spacing smaller than 12 cm is forbidden).

The weakest link in the entire chain design – metal expansion anchor and the individual elements of the ceiling structure – was the connection of bottom hanger and CD 60 profile ($F_u = 0.977$ kN), Figure 4a. In the suspended ceiling which had failed, every connection of bottom hanger and CD 60 profile was additionally reinforced by two 3.5*25 screws, Figure 4b. This solution was characterised by an average breaking load of $F_u = 2.00$ kN. Greater average breaking loads, in order from smallest to greatest, characterised bottom hanger rivets ($F_u = 2.54$ kN), ZSP anchor heads ($F_u = 3.10$ kN; Figure 4c) and KSMM anchor heads ($F_u = 3.24$ kN).

Fig. 4. Deformation of connection of bottom hanger and CD 60 profile – a, additional bonding of elements with two 3.5*25 screws – b, ZSP metal expansion anchor – c

- ▶ non-systemic application of additional bonding of the bottom hanger and CD 60 profile, using two 3.5*25 screws, results in the average load capacity of the connection being approx. two times greater.
