FAILURES OF SUSPENDED CEILINGS AND EXECUTION ERRORS

When observing the stability of suspended ceilings during operation, sometimes smaller failures are observed, up to disasters, even a few of considerable sizes and serious consequences. The aim of the article is to analyse the causes of damage to a suspended ceiling, with an area of approximately 500 m², as well as testing and checking the applied construction elements. In situ destructive tests as well as tests at the AGH laboratory were carried out. The analyses were carried out in accordance with PN/EN 13964: 2014 (E). It was found that the designed ceiling system solution was correct. Whereas in the performance, an improper spacing of hangers, even by more than 70% of the permissible spacing, and forbidden lengths of brackets from C60 profiles, were applied. Also, about 55% of the connectors had too small diameters of the ends of the mandrels, which allowed for the sliding of broken head and a sudden loss of carrying capacity of the hanger.

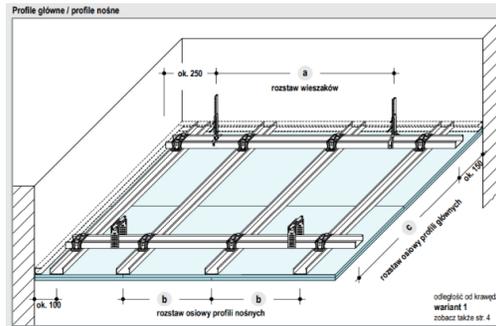
In the Knauf system, NIDA WGN 20 system, in respect of “Verification sizing of the ceiling”, point 4. Determining the basic geometric parameters, the axial distances of: hangers – a, main runners – c, and support tracks – b, is provided for, in line with Figure 2 and Table 1.

In line with the Knuf system, hangers with a load capacity of 0.30 kN, and – as indicated in Table 1 – axial distances $c = 110$ cm and $a = 75$ cm, should have been applied.

On the basis of a survey, it was found that main runner hangers in the failure area were present with the most unfavourable axial spacing of main runners $c_{\text{Imax}} = 105$ cm and $a_{\text{Imax}} = 130$ cm. The values permissible according to the Knauf system were exceeded significantly. Furthermore, other errors were observed. Due to the location of an access panel, the main runner was not continuous (one cantilever was 120 cm long and the other was 15 cm long). Some hangers were tensioned and subjected to significant loads, some were less tensioned, and a few were completely loose (this could have been caused by rectification of the floor slab level only in respect of selected hangers, with the adjacent ones remaining unadjusted). A small number of hangers were fixed with an approx. 15% tilt from the vertical due to conflicts with installation routes.

Fig. 2. Geometric parameters according to Knauf NIDA WGN 20
