SELECTED OPERATING PROBLEMS OF CENTRAL PUMPS

The article presents problems of maintaining the Z-type supply pumps and network operated in ENEA Wytwarzanie Sp. z o.o. Heat Segment, Białystok Branch with the use of thermovision and vibrodiagnostic studies. The practical aim is to select parameters of the supply pumps (multistage) which ensure energy efficient operation despite a serious operational wear - a 20-year working period. Commissioning of a Z-type feed pump and thermovision tests of selected machine construction elements constituted the subject of the research.

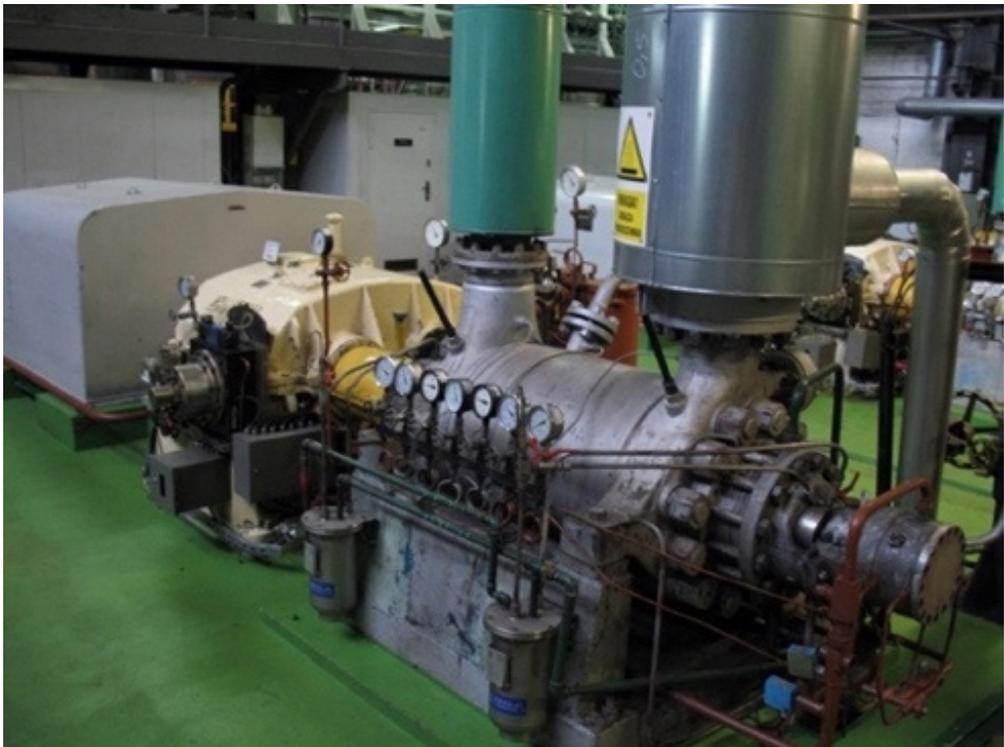
Fig. 1. Steam water pump for the Z-type steam boiler

the pump is properly inflated, which is always determined. The pump is covered with an insulating mattress and a sheet steel cover. In Fig. 1, photographs illustrate a feed water pump operated at ENEA Wytwarzanie Sp. z o.o. Heat Segment, Białystok Branch.

Housings have horizontal paws in the axial plane to support the pump on the foundation slab. Each member consisting of a step ring, a rotor and a steering wheel is one pump stage. The tightness between individual step rings is ensured by the pressure of lapped sealing surfaces. The pump shaft is guided in radial slide bearings and in a two-way sliding Michella bearing type. Bearings are circulated by oil under pressure. In the place of passage through the gland, the shaft is protected by exchangeable sleeves and sealed with an intense cooling water sealant. Glands together with stuffing box covers are attached to the suction and discharge body of the pump. The axial thrust of the rotating assembly is balanced by the unloading disc and the sliding axial bearing. In addition to inlet and outlet chutes, the pumps have two others: the first one allows for the injection of steam and the second for connecting the pump with the minimum controlled flow valve.

Incomplete load of the tested Z-pump (Fig. 1) results from water supply to only one boiler. This type of pump load occurs in summer periods due to a lower demand for thermal energy. The pump shows resonant vibrations, which indicates the need to perform the above-mentioned diagnostic tests to prevent unforeseen emergency stoppages.

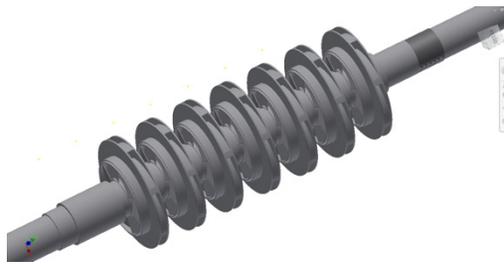
Fig. 2 presents the rotor model made in the Autodesk Inventor Professional environment. Fig. 5 presents selected results of thermovision tests carried out on bearing housings.

Fig. 2. Rotor model of the Z-type feed pump

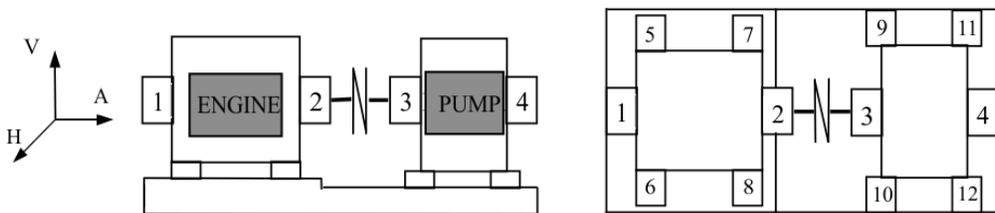
Fig. 3. Scheme of measurement points on the pump set

The measurements were carried out using a KSD 400 vibration analyzer with an eddy current sensor. The effective value of vibration velocity (in mm/s) was measured with automatic selection of bandwidth and filtration.

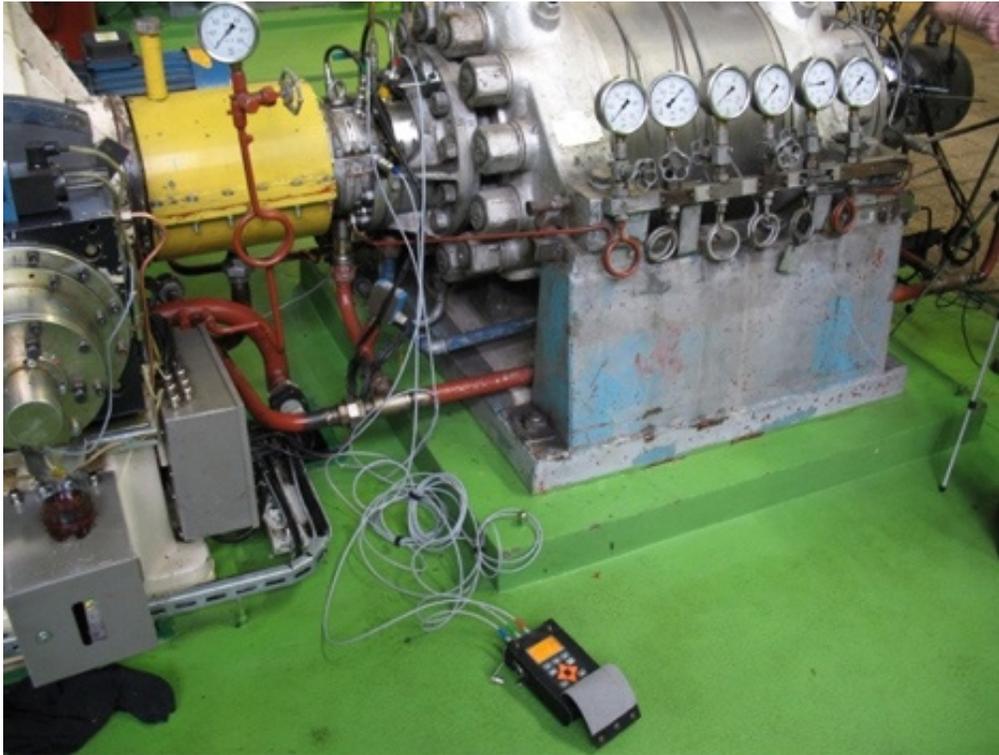
For testing of bearing shells, DIAMOND 401 high quality measuring equipment (Fig. 4) was used together with sensors. The tests were supplemented with measurements from a KSD 400 computerized vibration analyzer. The results of the measurements were presented in graphical form in Figs. 6 and 7.

Fig. 4. Diagnostic apparatus used during experimental research

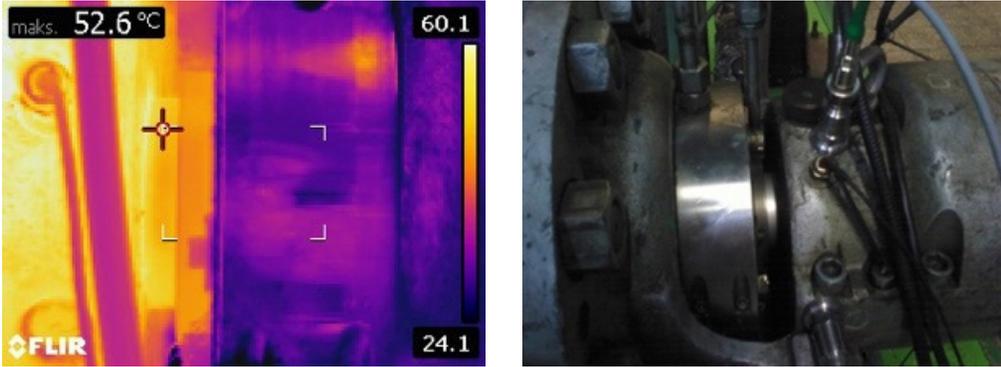
Fig. 5. Testing with the FLIR thermovision camera Z-pumps

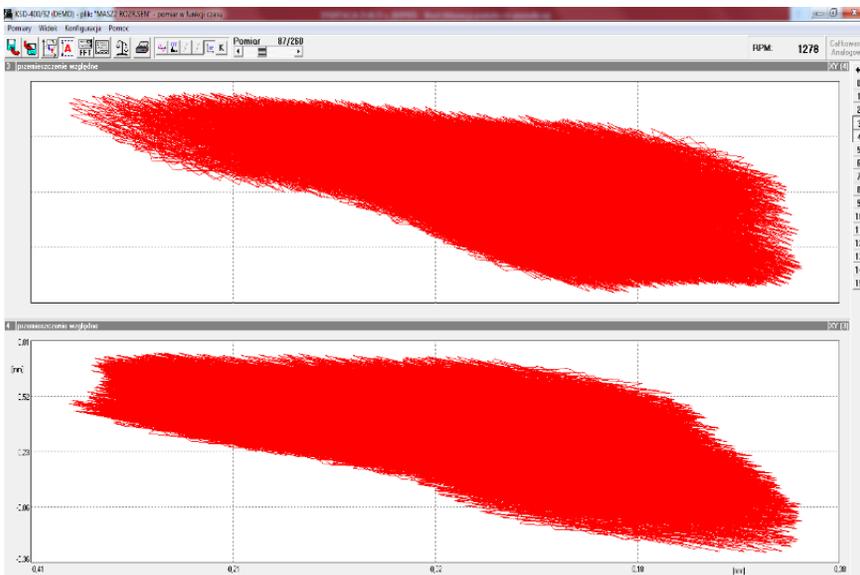
It can be stated that at the beginning (below 1500 revolutions per minute) there appears non stability synchronized by the rotation of the shaft, bearing the name of an oil whirl. This phenomenon is manifested in a graphical form as a loop filled with red.

Fig. 6. Screenshot of the KSD 400/32 program - measurement 87 - RPM 1278

The results of the diagnostic tests are presented below in a simple graphical form (Figs. 6 and 7).

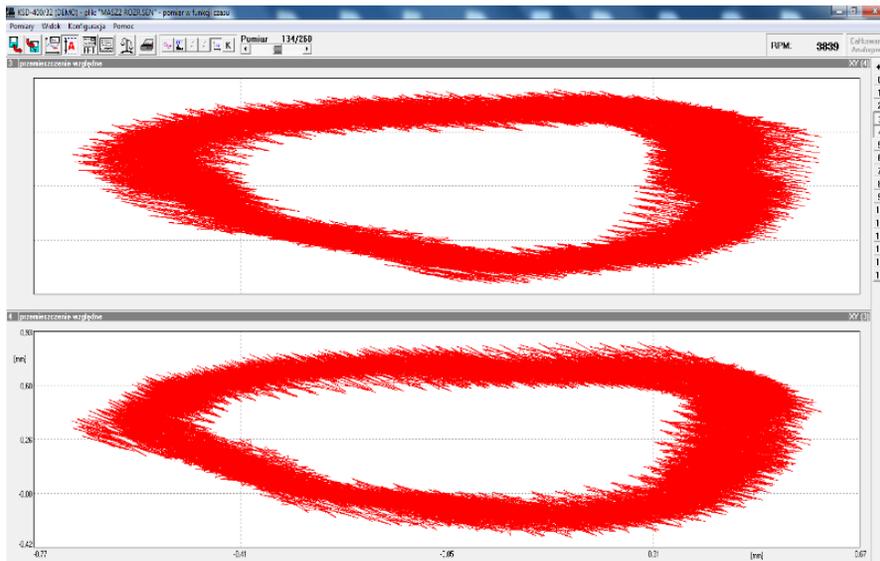
Fig. 7. Screenshot of the KSD 400/32 program - measurement 134 - RPM 3839

The loop begins to take the form of an ellipse with an open center after exceeding 3000 rpm, because the forces caused by rotation are then sufficient to stabilize the oil film. The rotor speed of the rotor stabilizes within the range of 3600–4000 rpm. A further increase in rotor speed would lead to instability, oil vortex, up to the speed corresponding to two times the vibratory frequency of the rotor. Above this speed, the rotor frequency (flexural vibrations) becomes the synchronizing factor.
