ANNA MŁYŃSKA, MICHAŁ ZIELINA*

EXPERIMENTAL RESEARCH
ON THE IMPACT OF DIFFERENT HARDNESS WATERS
ON THEIR CONTAMINATION BY PROTECTIVE
CEMENT MORTAR LININGS AFTER PIPE RENOVATION

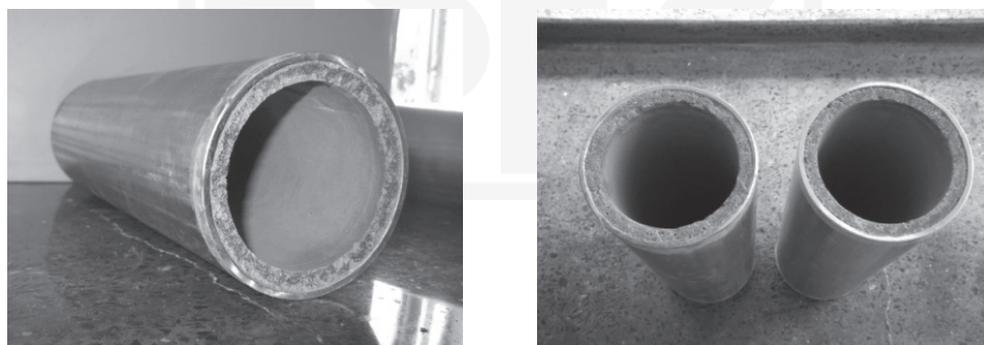
Fig. 2. Steel pipes with internal cement coating (Source: author's photo)

The length of water pipes with the nominal diameter of 80 mm was 25.0 cm. The thickness of cement mortar coating was 0.7 cm and was made by mixing Portland Cement 42.5R manufactured by CEMEX with quartz sand in a ratio of 1 to 1 and with water, maintaining 0.35 water-cement ratio. Cement mortar lining process was made manually with 24 hours cure time. After this time, pipes interiors were filled with water samples collected from
